**Flood Control Project Maintenance
Levee Inspections**

Fall 2012 Levee Maintenance Deficiency Summary Report

**Flood Control Project Maintenance
Levee Inspections**
LMA District Cover Sheet
Fall 2012 Levee Inspection Results

Butte County Public Works Department Butte County Public Works

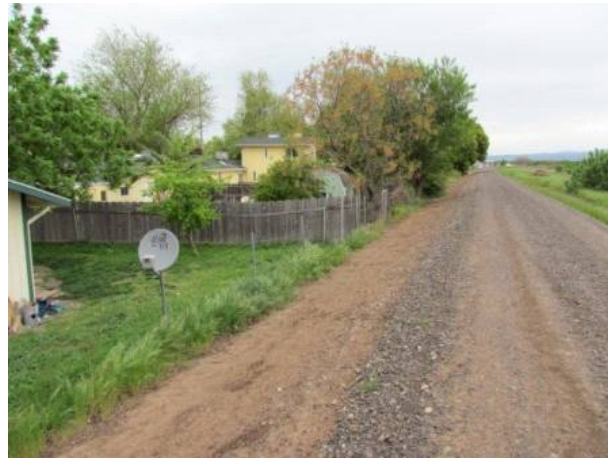
Levee Mile Report Line	4
Start Levee Mile	2.06
End Levee Mile	2.10
Location	Land Side
Category	Earthen Levee
Item	Encroachments

View of the fences along the L/S toe.

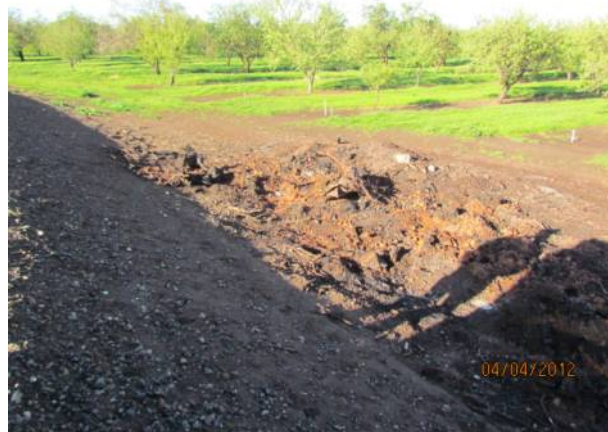
Levee Mile Report Line	7
Start Levee Mile	2.65
End Levee Mile	2.65
Location	Land Side
Category	Earthen Levee
Item	Encroachments

7	2.65	2.65	Earthen Levee	Encroachments	LS	A En	PR : Prunings Inspector Comments: The prunings pile has been removed.	39.755897 ° -121.914808 °	39.755897 ° -121.914808 °	2 Y
DWR ID: DWR_NA0003_01_s_2012_2										
8	2.90	2.90	Earthen Levee	Animal Control	LS	A Ma	A3 : No rodents visible, but rodent burrows visible; need to backfill and compact or grout burrows. Inspector Comments: The rodent holes been filed with grout.	39.758788 ° -121.912383 °	39.758788 ° -121.912383 °	11 Y
DWR ID: DWR_NA0003_01_s_2012_11										
9	3.00	3.00	Earthen Levee	Encroachments	LS	M Ma	PR : Prunings	39.759755 ° -121.911160 °	39.759755 ° -121.911160 °	1 Y
DWR ID: DWR_NA0003_01_s_2012_1										
10	3.10	3.10	Earthen Levee	Encroachments	LS	M Ma	PR : Prunings	39.761085 ° -121.911048 °	39.761085 ° -121.911048 °	25
DWR ID: DWR_NA0003_01_s_2012_25										
11	3.22	3.22	Earthen Levee	Animal Control	LS	A Ma	A3 : No rodents visible, but rodent burrows visible; need to backfill and compact or grout burrows. Inspector Comments: The rodent holes have been filled with grout.	39.762548 ° -121.909872 °	39.762547 ° -121.909868 °	6 Y

The prunings have been removed from the toe of the levee.

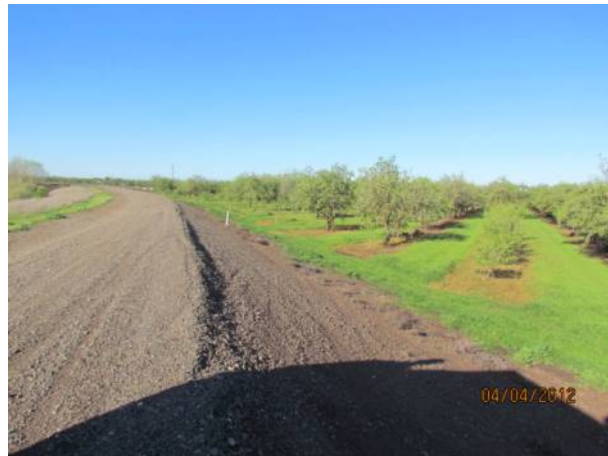
Levee Mile Report Line	8
Start Levee Mile	2.90
End Levee Mile	2.90
Location	Land Side
Category	Earthen Levee
Item	Animal Control

The rodent holes have been grouted by Butte County.

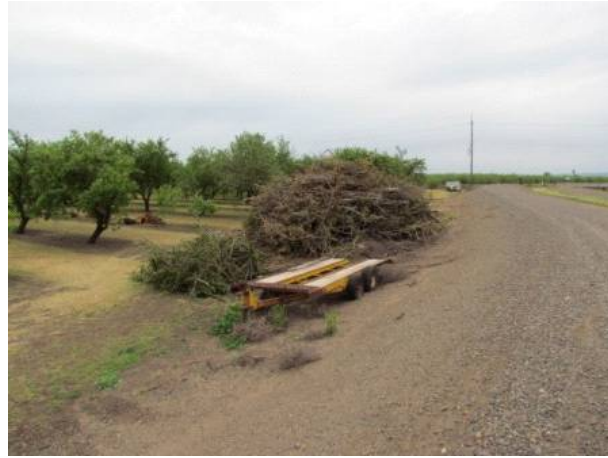
Levee Mile Report Line	9
Start Levee Mile	3.00
End Levee Mile	3.00
Location	Land Side
Category	Earthen Levee
Item	Encroachments

View of the pruning pile along the L/S toe.

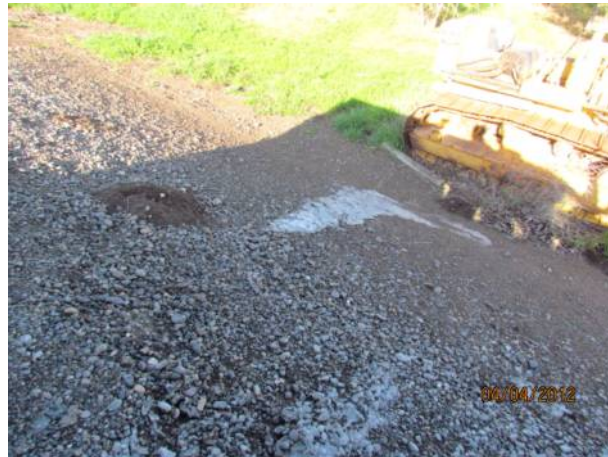
Levee Mile Report Line	11
Start Levee Mile	3.22
End Levee Mile	3.22
Location	Land Side
Category	Earthen Levee
Item	Animal Control

The rodent holes have been grouted by Butte County.

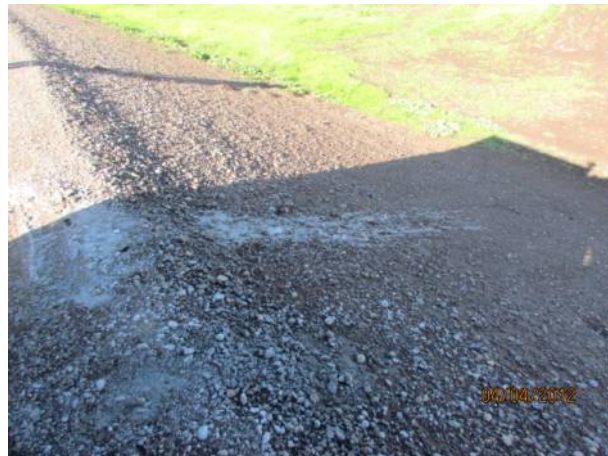
Levee Mile Report Line	12
Start Levee Mile	3.33
End Levee Mile	3.33
Location	Land Side
Category	Earthen Levee
Item	Animal Control

DWR ID: DWR_NA0003_01_s_2012_6										
12	3.33	3.33	Earthen Levee	Animal Control	LS	A Ma	A3 : No rodents visible, but rodent burrows visible; need to backfill and compact or grout burrows. Inspector Comments: The rodent hole have been filled with grout.	39.764123 ° -121.908970 °	39.764123 ° -121.908970 °	12 Y
DWR ID: DWR_NA0003_01_s_2012_12										
13	3.98	3.98	Earthen Levee	Encroachments	LS	M Ma	PR : Prunings	39.770351 ° -121.901349 °	39.770351 ° -121.901349 °	5
DWR ID: DWR_NA0003_01_s_2012_5

The rodent holes have been grouted by Butte County.

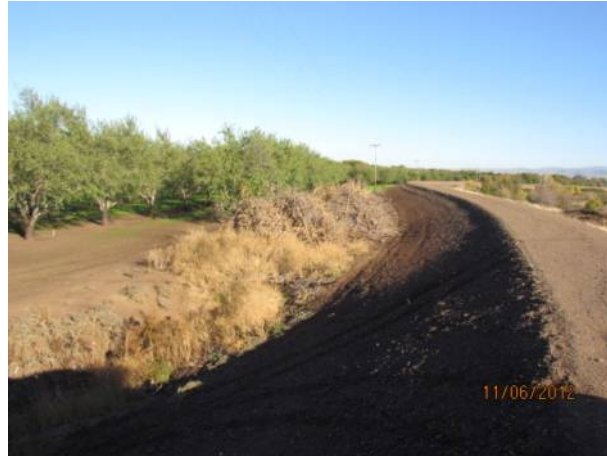
Levee Mile Report Line	15
Start Levee Mile	4.58
End Levee Mile	4.58
Location	Land Side
Category	Earthen Levee
Item	Encroachments

View of the brush pile along landside toe.

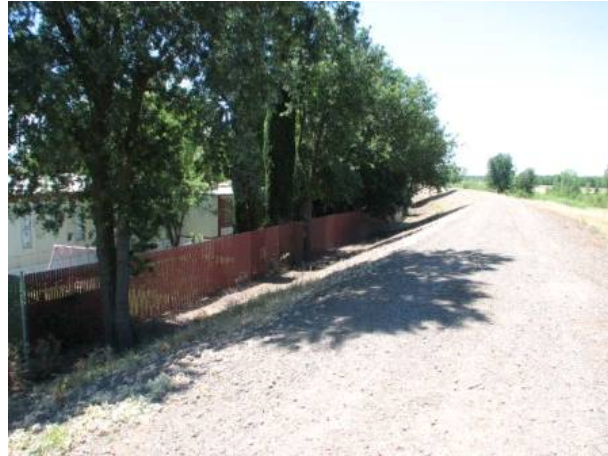
Levee Mile Report Line	1
Start Levee Mile	1.58
End Levee Mile	1.90
Location	Land Side
Category	Earthen Levee
Item	Encroachments

LMR No.	Levee Mile		Category	Item	Location *	Rating **	Action/Comment	GPS Latitude/Longitude		Issue No. Photo
	Start	End						Start	End	
1	1.58	1.90	Earthen Levee	Encroachments	LS	U En	FE : Fence	39.782773 ° -121.888178 °	39.778972 ° -121.891563 °	3 Y
DWR ID: DWR_NA0003_02_s_2012_3										
2	3.42	3.42	Earthen Levee	Encroachments	LS	M Ma	PR : Prunings	39.763208 ° -121.908517 °	39.763208 ° -121.908517 °	5 Y
DWR ID: DWR_NA0003_02_f_2012_5										
3	4.70	4.70	Earthen Levee	Encroachments	LS	M En	PR : Prunings	39.749727 ° -121.917112 °	39.749727 ° -121.917112 °	1 Y
DWR ID: DWR_NA0003_02_s_2012_1

View of the fence along the landside toe of the levee.

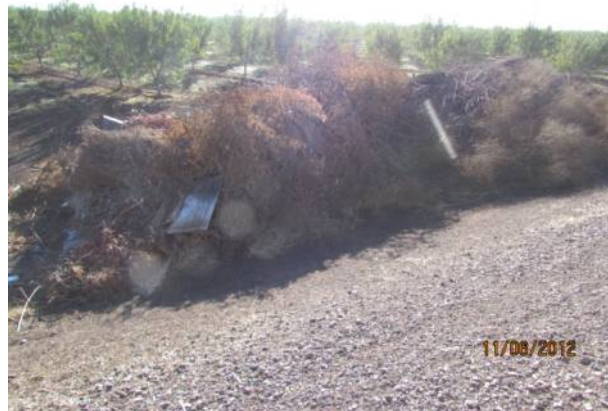
Levee Mile Report Line	2
Start Levee Mile	3.42
End Levee Mile	3.42
Location	Land Side
Category	Earthen Levee
Item	Encroachments

View of the brush pile along landside toe.

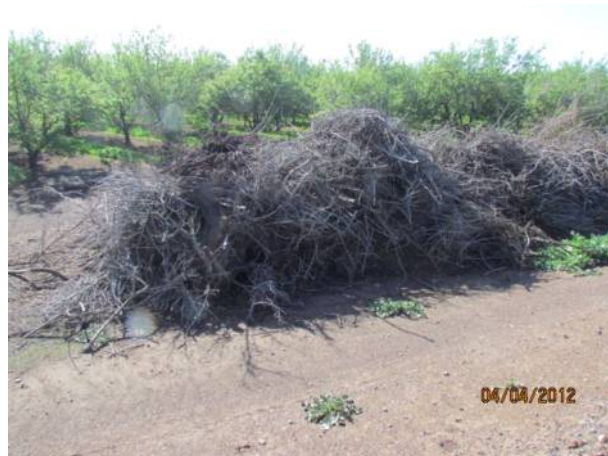
Levee Mile Report Line	3
Start Levee Mile	4.70
End Levee Mile	4.70
Location	Land Side
Category	Earthen Levee
Item	Encroachments

View of the tree prunings at the toe of the levee.

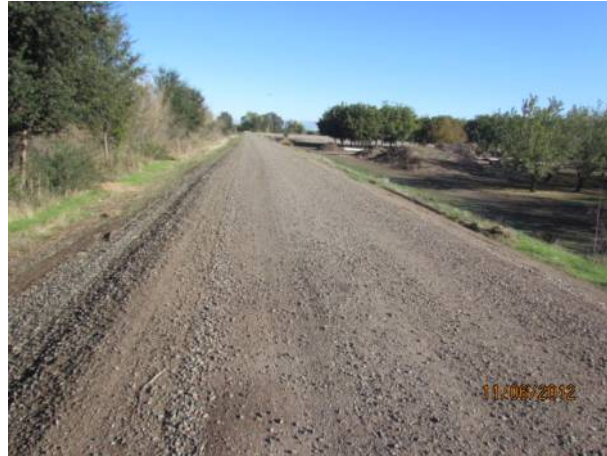
LMR No.	Levee Mile		Category	Item	Location *	Rating **	Action/Comment	GPS Latitude/Longitude		Issue No.
	Start	End						Start	End	Photo
1	0.00	0.30	Earthen Levee	Vegetation	LS	A	V1 : Control annual grass and weeds on the levee slopes and easements.	39.734225 ° -121.929544 °	39.734225 ° -121.929544 °	3 Y
DWR ID: DWR_NA0003_02A_f_2012_3

Levee Mile Report Line	1
Start Levee Mile	0.00
End Levee Mile	0.30
Location	Land Side
Category	Earthen Levee
Item	Vegetation
View of the levee with all vegetation removed.	
rduffey_f_20121128_351.JPG

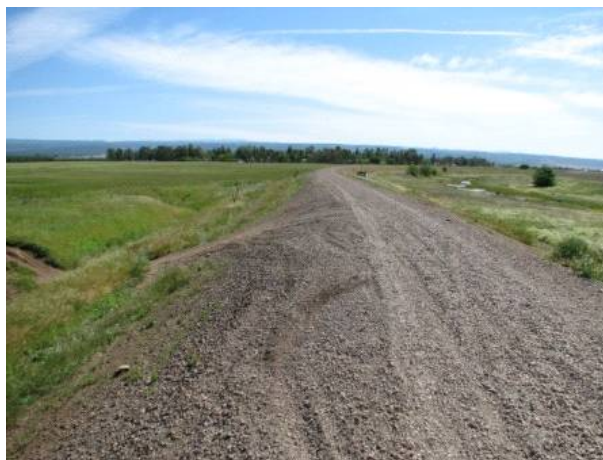
Levee Mile Report Line	1
Start Levee Mile	0.06
End Levee Mile	0.06
Location	Water Side
Category	Earthen Levee
Item	Slope Stability

LMR No.	Levee Mile		Category	Item	Location *	Rating **	Action/Comment	GPS Latitude/Longitude		Issue No.
	Start	End						Start	End	
1	0.06	0.06	Earthen Levee	Slope Stability	WS	M	S3 : Repair the levee slope damaged by vehicle traffic and prevent access where possible.	39.786068 ° -121.881828 °	39.786068 ° -121.881828 °	3 Y
DWR ID: DWR_NA0003_03_s_ 2012_3										
2	1.78	1.78	Earthen Levee	Vegetation	LS	A	V1 : Control annual grass and weeds on the levee slopes and easements.	39.779572 ° -121.853285 °	39.779572 ° -121.853285 °	4 Y
DWR ID: DWR_NA0003_03_f_ 2012_4

View of the motorcycle erosion on the landside slope of the levee.

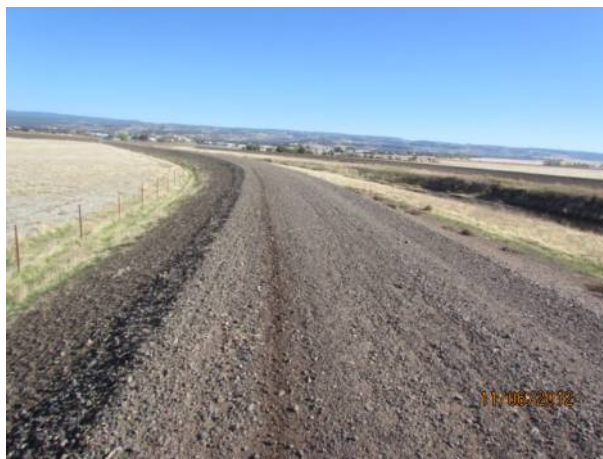
Levee Mile Report Line	2
Start Levee Mile	1.78
End Levee Mile	1.78
Location	Land Side
Category	Earthen Levee
Item	Vegetation

View of the levee with all vegetation removed.

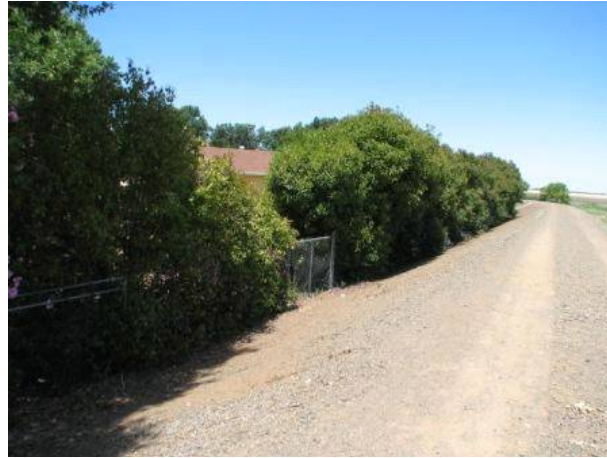
View of the fence and trees along the landside toe of the levee.

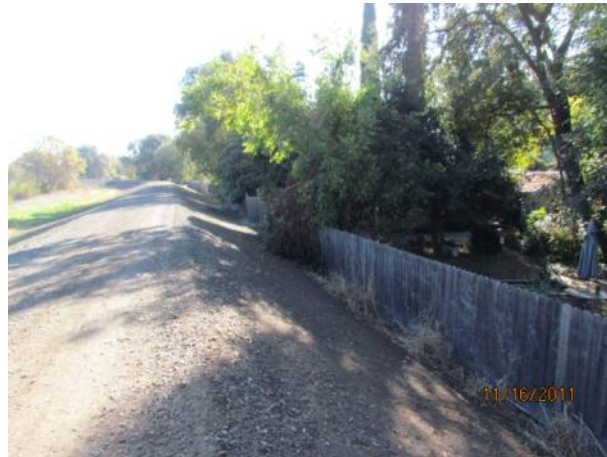
Levee Mile Report Line	2
Start Levee Mile	1.16
End Levee Mile	1.27
Location	Land Side
Category	Earthen Levee
Item	Encroachments

View of the fence along the L/S toe.

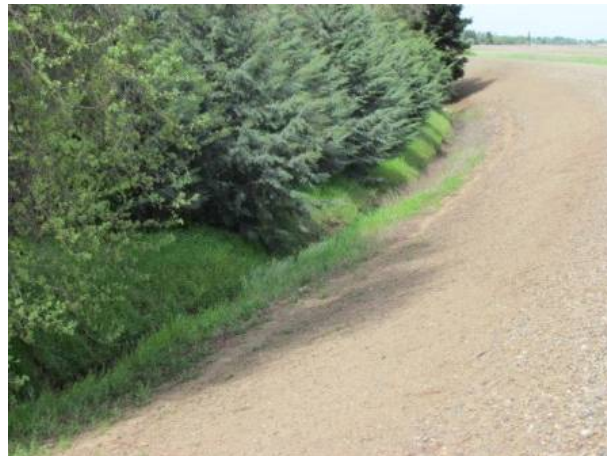
Levee Mile Report Line	3
Start Levee Mile	1.32
End Levee Mile	1.40
Location	Land Side
Category	Earthen Levee
Item	Encroachments

View of AG ditch at the L/S toe.

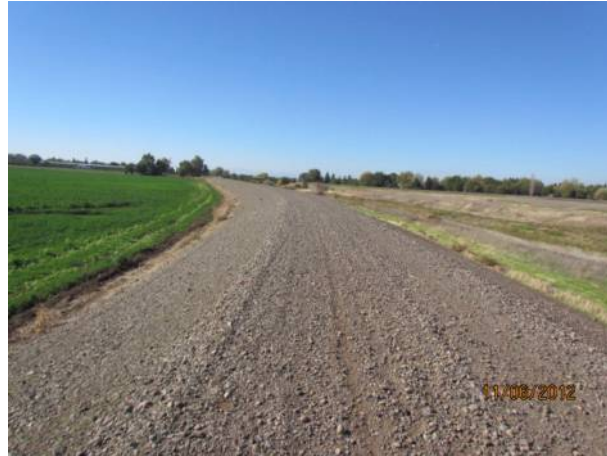
Levee Mile Report Line	4
Start Levee Mile	2.78
End Levee Mile	2.78
Location	Land Side
Category	Earthen Levee
Item	Vegetation
View of the levee with all vegetation removed.	
rduffey_f_20121128_353.JPG

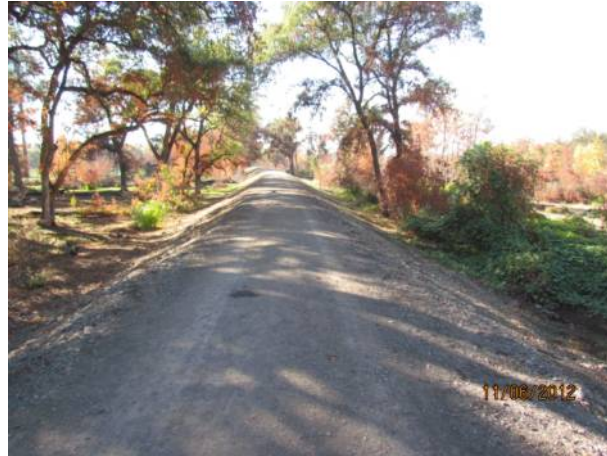
Levee Mile Report Line	1
Start Levee Mile	0.22
End Levee Mile	0.22
Location	Land Side
Category	Earthen Levee
Item	Vegetation
View of the levee with all vegetation removed.	
rduffey_f_20121128_354.JPG
